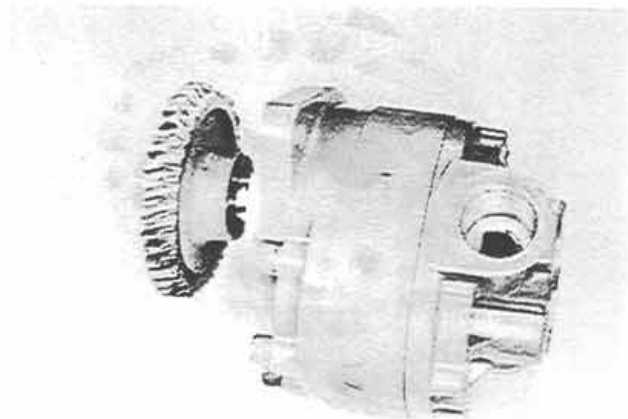
Figure 44:

Pumps which have the engine gear directly on the pump drive shaft must be mounted squarely and torqued evenly to the engine flange. Otherwise edge loading can cause failure of the engine gear teeth. (See Fig. 44)

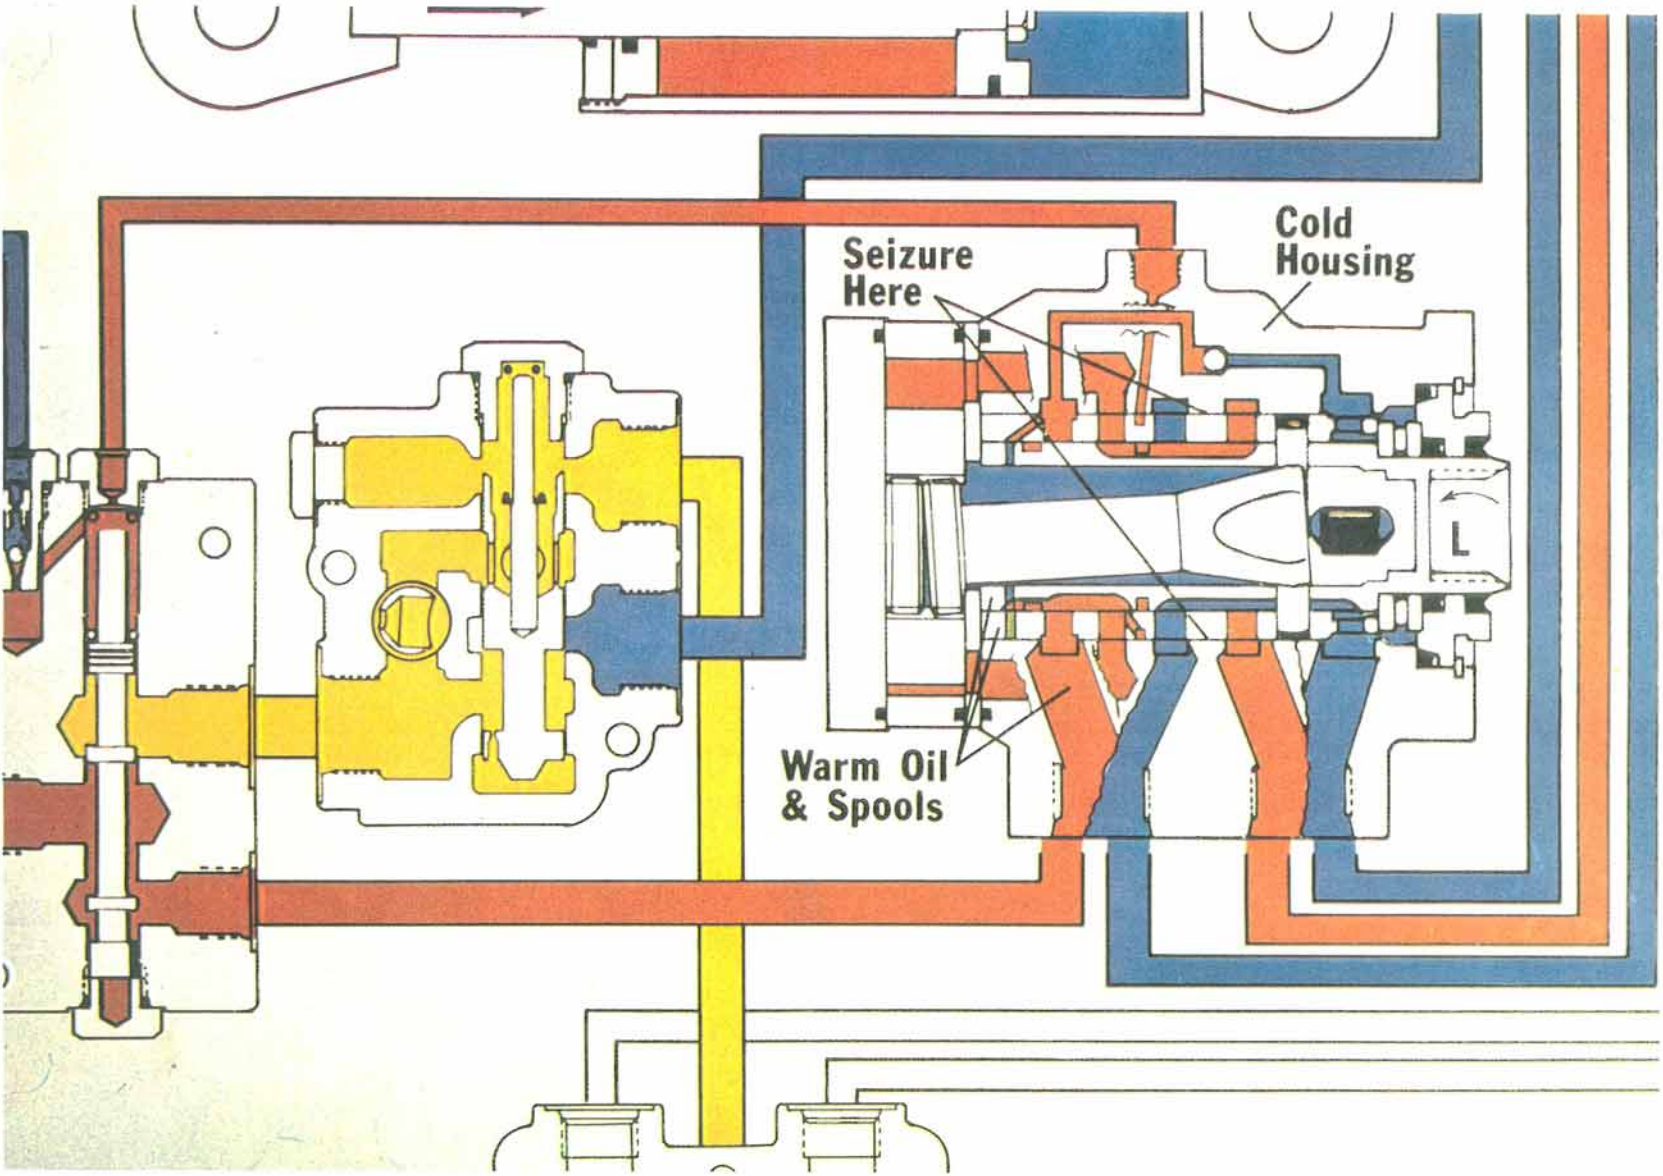
Figure 46:

You may encounter a complaint from a customer that said, "It steers normally, but sometimes locks up before operating normally again." The symptom described here is thermal shock. When the hydraulic system is operating at a much higher temperature than the steering valve and suddenly the steering is used, a fast temperature change may "swell" the spools inside of the housing. (See Fig. 46)

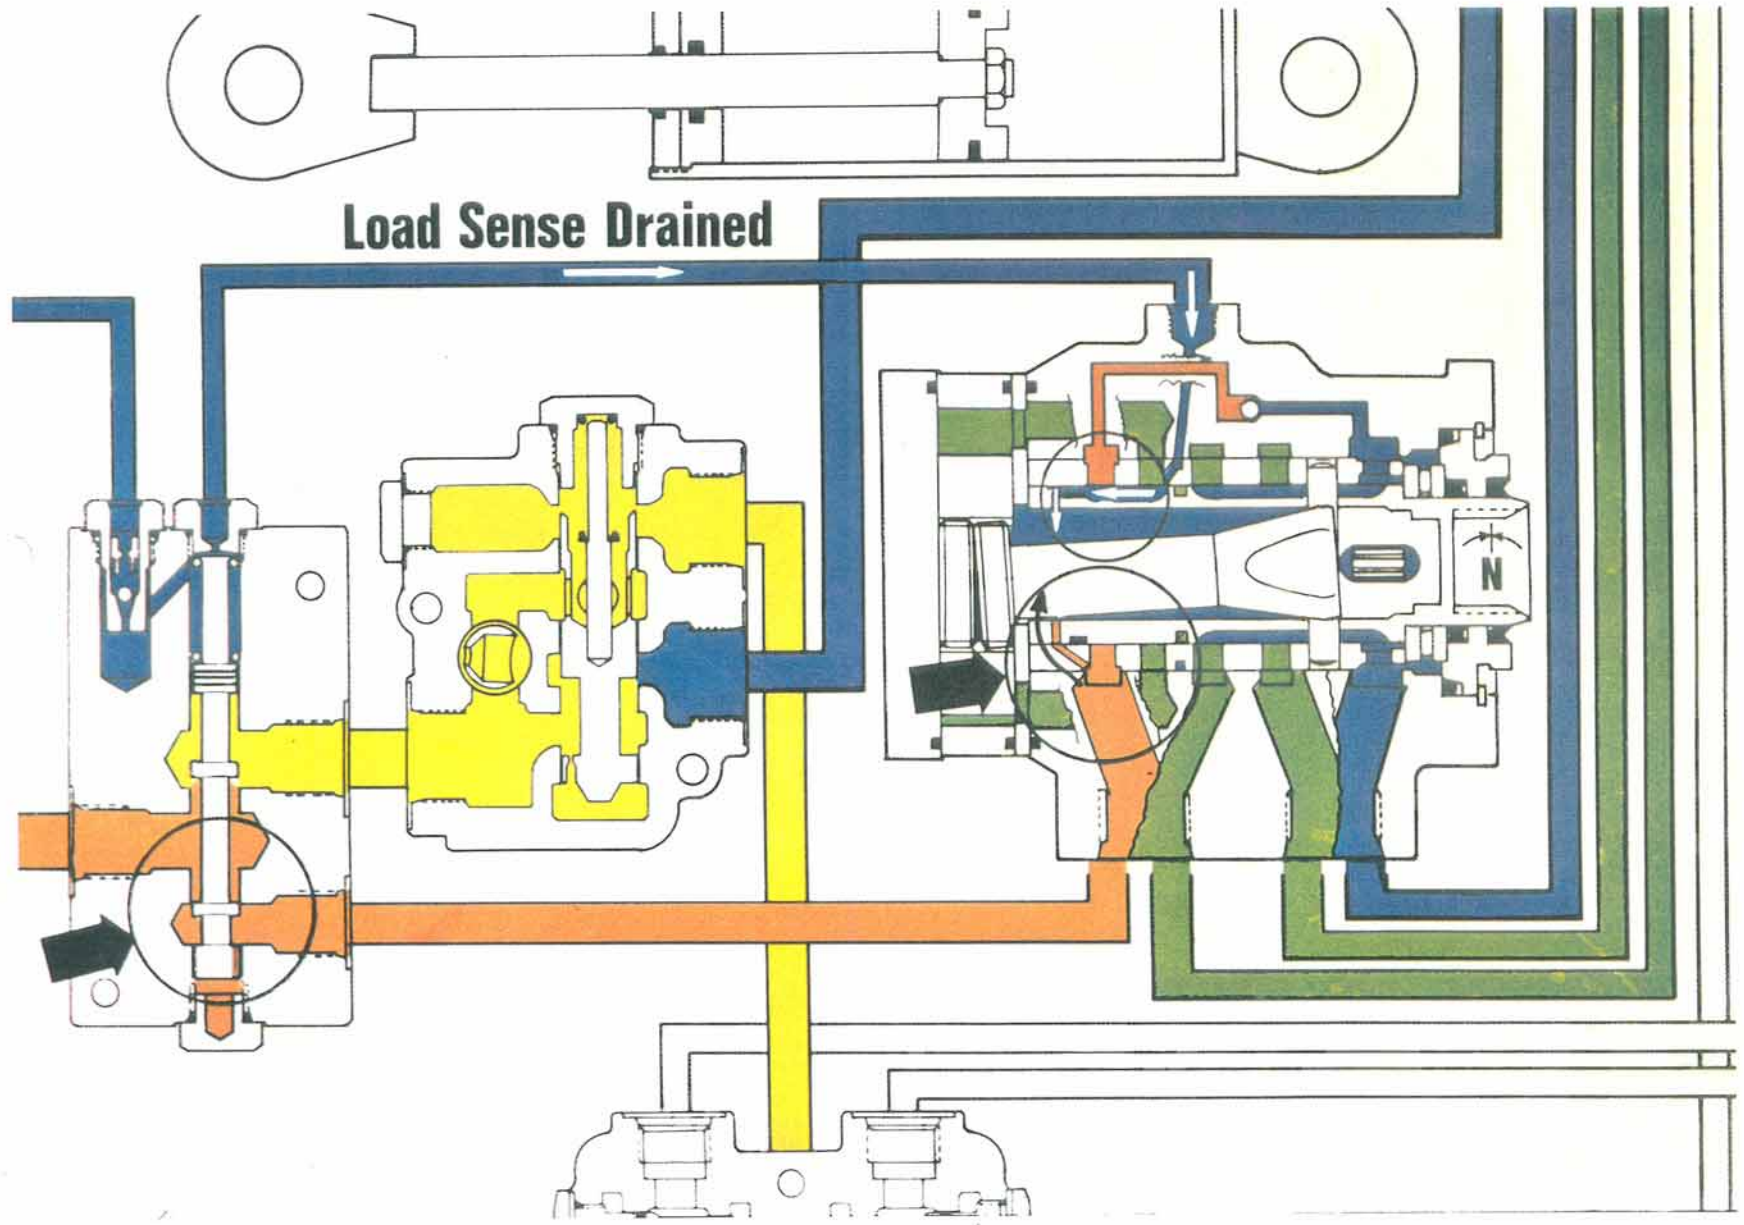
Figure 47:

After the whole assembly stabilizes in temperature, it will usually resume normal functions. Remember that a small quantity of oil at system temperature must pass through the valve during neutral steering demands. If any blockage prevents proper flow and temperature stability, then thermal shock can occur. Inside the steering valve, ensure that all passages are open and all parts are absolutely free of debris. Note that it would also be wise to check the entire load-sense circuit for cleanliness. (See Fig. 47)

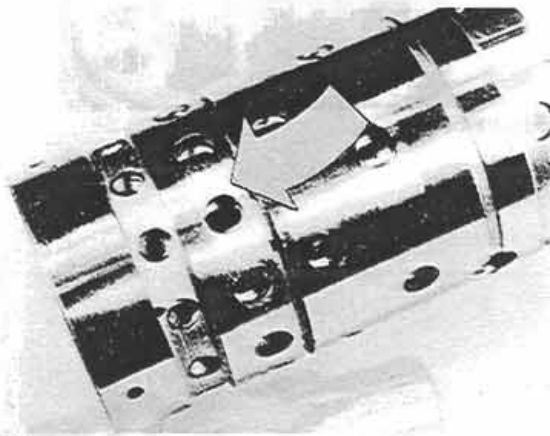
Figure 49:

The manner in which contamination affects the valve can have varied, or even a combination of visual signs. Again, it is dependent upon particle size, type and amount. When we see a surface that appears chipped, scuffed or worn, it is unacceptable for further use as uncontrolled internal leakage will affect performance. Wear that is seen here is the result of dirt being present in the oil. Nothing may happen at first, but wear is increased with continued usage. (See Fig. 49)

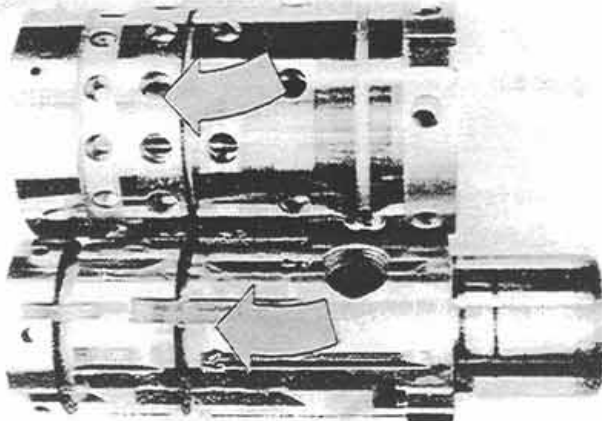
Figure 50:

With oil which contains metal particles such as a failure from another part of the system, there is a tendency for chipping or scoring at the metering edges of the ports. If severe or sudden enough, it can end with total seizure of the unit. The example shown indicates such a condition and had to be pressed apart. (See Fig. 50)

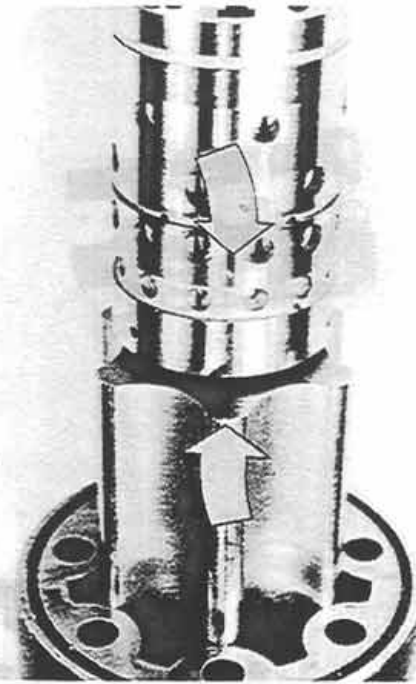
Figure 51:

Look for good correlation between the gerotor and outer spool. All driving members which connect the two should have no visible wear, other than being polished. This is necessary to maintain correct timing for proper delivery in either direction. Gerotor and stator running clearance is generally disregarded. Rather, judge the finish condition in the same manner as described for the spools. (See Fig. 51)
